**Vertical Profiler Water Quality Monitoring
in the Tred Avon River –
June 2015 to September 2015**

February 10, 2015

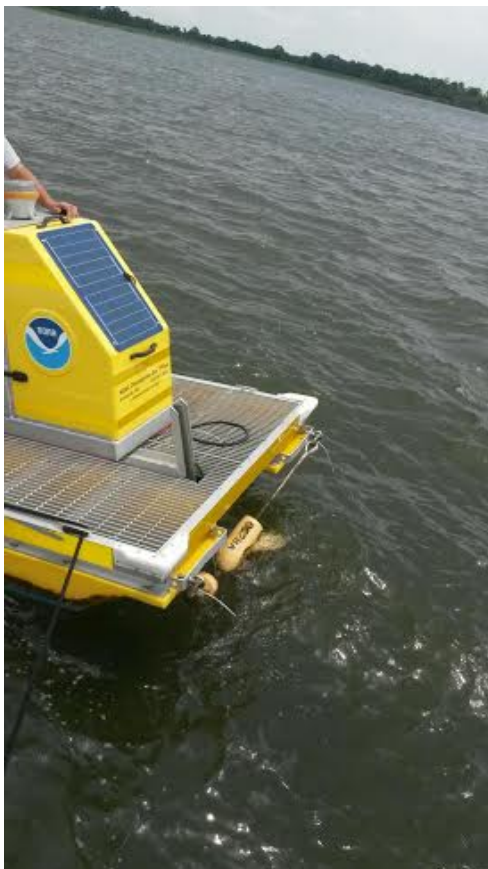
DNR staff visited the site on July 27, 2015 to further investigate the depth sounder issues. At that time, DNR field personnel noticed that the anchor line for the profiler had become wrapped around the transducer pole for the depth sounder (Figure 1). DNR staff returned to the site on July 30, untangled the anchor line, and moved the point of attachment for the line to the “stern” of the profiler platform to prevent future entanglement. The depth sounder was also found to be heavily fouled (Figure 2), so field staff cleaned and reinstalled the depth sounder. Unfortunately, field efforts to restore operation to the equipment were not successful. The depth sounder continued to malfunction, frequently switching the profiler into “standby” mode.

Figure 1. Tangled anchor line.

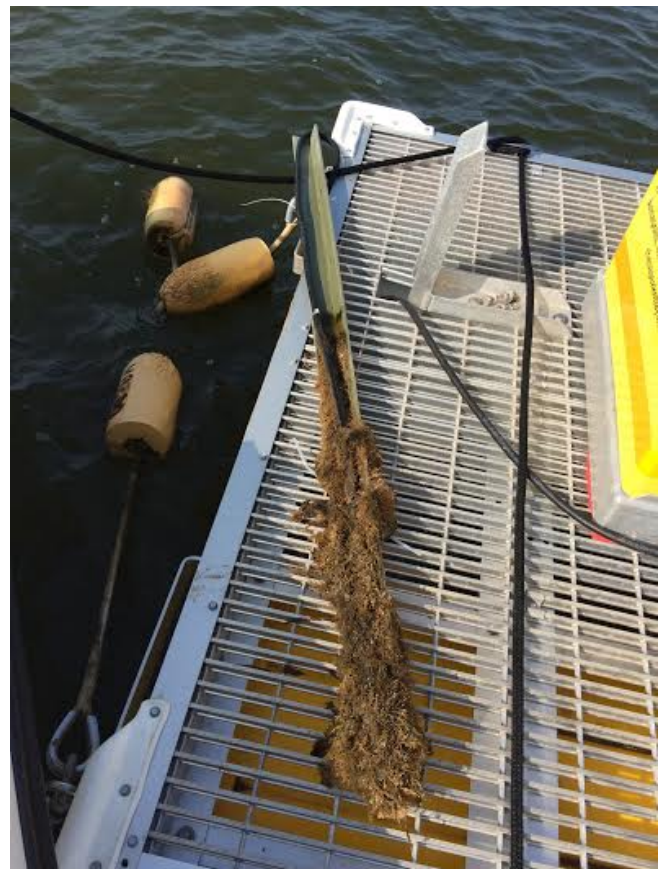
Figure 2. Biofouling on depth sounder.

It should be noted that biofouling of the equipment is a major issue at the Tred Avon site. As with the depth sounder, data sondes were often found to be covered in heavy growth when retrieved for cleaning and post-calibration. In addition to possibly impacting the performance of the depth sounder, biofouling may also contribute to inaccurate readings of water quality parameters by the data sondes.

Biofouling of equipment continues to be a major concern in the Tred Avon River and may need to be addressed, either with more frequent visits to the site or with the use of additional anti-fouling techniques. Biofouling contributed to some data values being censored during data quality assurance procedures and may also have been a factor in the poor performance of the depth sounder.
