Lake Water Quality Monitoring

Hydrilla Treatment and Monitoring

Submerged Aquatic Vegetation (SAV) Monitoring

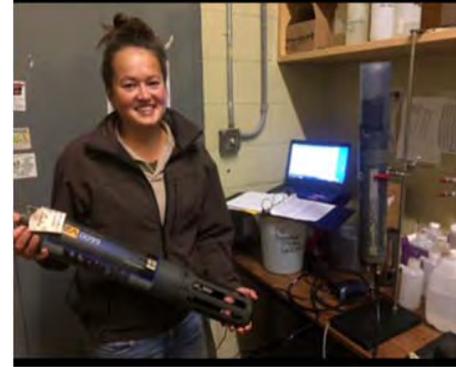
DNR technician calibrating continuous water quality meter for deployment in lake

Additionally, continuous monitoring meters (pictured right) were deployed in as many as 10 coves around the lake to gain a better understanding as to how these shallow water systems function. These meters record various water quality data autonomously every 15 minutes. Meters were deployed during the spring and fall particularly in the coves that have larger tributaries. In these areas, meters were often deployed in pairs, with one meter in the cove and the other meter near the mouth of the tributary to better understand the impacts of the tributary on water quality in the cove. During the summer months, the meters were rotated in many of the shallow water coves that were simultaneously included in the lake wide monitoring in an effort to better understand how water quality varies over time. When resources allowed, meters were deployed in pairs, with one meter located in the cove and the other near the shoreline in an effort to better understand the effects of changing water levels, boat wakes and shoreline erosion and relate that to water quality in the main portion of the cove. Water quality data from the 2017 sampling season is currently undergoing review but natural resource managers are learning a great deal about the spatial and temporal variability in the lake and better understanding how the tributaries of the lake and the nearshore environment relate to the deeper mid-water stations.

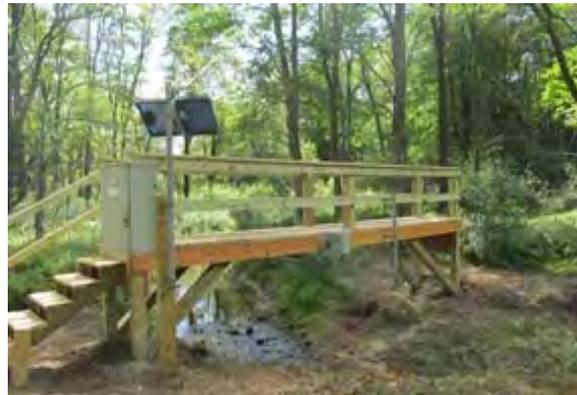
Pictured above: USGS Stream gage located at North Glade Run. The gage was installed in August 2016
 Pictured below: Example of discharge data available online from USGS

The Deep Creek Lake Natural Resource Management Area (DCL NRMA) has been working with US Geological Survey (USGS) to monitor the flow of incoming water into DCL. As of 2017, DNR and USGS together monitor water flow and water quality of 3 tributaries (Cherry Creek, North Glade Run and Arrowhead Run) of Deep Creek Lake. The goal of this is to determine the quantity of water entering DCL as well as assess the quality of water coming in based on the amount of sediments and nutrients entering the lake from these streams. This data can help managers understand how the watershed affects the quality of receiving waters and possibly identify sub-watersheds in need of additional study. The USGS gage data is available real-time at :
