# 2010 Bush River Shallow Water Monitoring Data Report

DNR publication #12-9272011-528

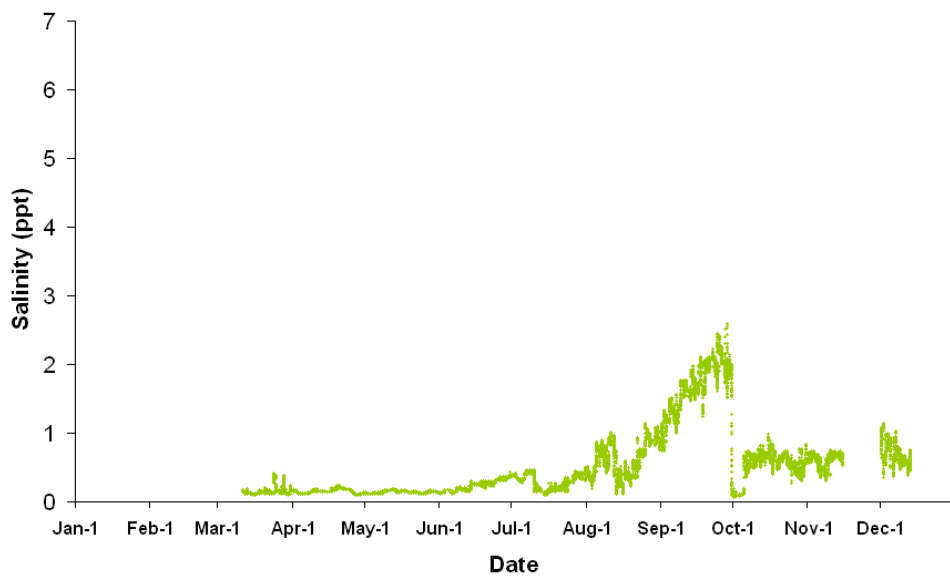
Salinity levels for both the Church Point and Otter Point Creek Continuous Monitoring sites remained low for most of the spring and summer (Figure 5). Levels then increased during the late summer and early fall, before dropping off on in late September following the influx of fresh water from the remnants of Tropical Storm Nicole. Church Point salinity levels peaked at 3.4 parts per thousand (ppt) and Otter Point Creek levels peaked at 2.6ppt.

Figure 5. Salinity levels at Bush River Continuous Monitoring sites during 2010.

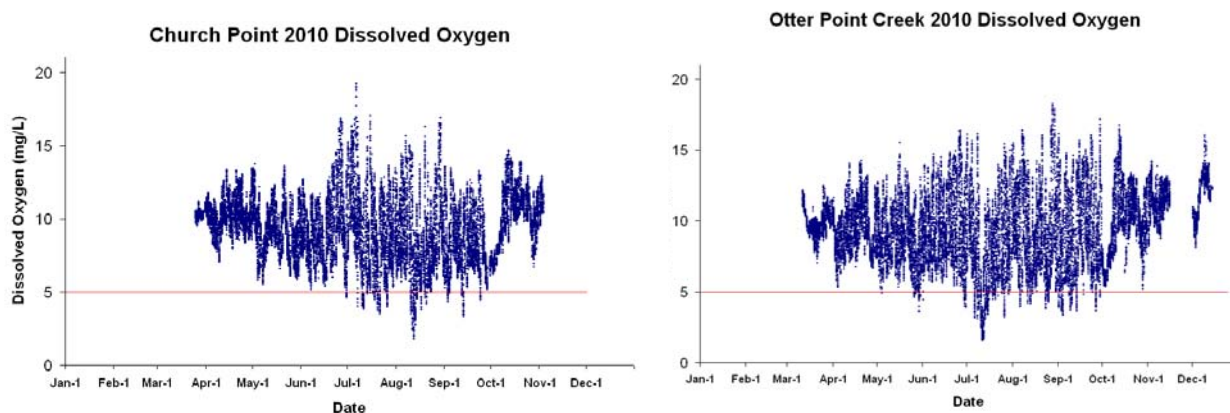
The highest dissolved oxygen concentration measured at Church Point was 19.27mg/l on July 6<sup>th</sup>, and the lowest was 1.84mg/l on August 12<sup>th</sup>. In general, dissolved oxygen levels were concentrated around 6-10mg/l during the summer months and 4.8% of 8,655 valid readings between July and September were below 5mg/l (Table 3). At Otter Point Creek, dissolved oxygen concentrations reached a high of 18.27mg/l on August 28<sup>th</sup> and a low of 1.60mg/l on July 11<sup>th</sup>. 8.3% of 8,818 valid readings at Otter Point Creek between July and September were below 5mg/l, which represents an approximately 110% increase in criteria failure rate since 2009 (Table 2).

**Figure 6. Dissolved oxygen levels at Bush River Continuous Monitoring sites during 2010.**

*(Red line indicates threshold below which levels can lead to ecosystem stress.)*

In 2010, both Continuous Monitoring sites were located closer to the head waters than the mouth of the Bush River (Figure 1) and exhibited similar variability in dissolved oxygen levels (Figure 6). Both sites also experienced relatively few days of dissolved oxygen concentrations below 5 milligrams per liter (mg/l), although the rate of dissolved oxygen criteria failure at Otter Point Creek more than doubled as compared to 2009 (Table 3). This criteria threshold has been set by the US Environmental Protection Agency (EPA) because dissolved oxygen levels below 5mg/l can be detrimental to the survival of juvenile fish (US EPA, 2003).

Algal blooms in waterways are identified by measuring chlorophyll concentrations and dissolved oxygen levels often drop following the death and decomposition of algal blooms and associated decreases in chlorophyll levels. The decomposition process can consume significant amounts of dissolved oxygen in the water and can lead to conditions harmful to aquatic organisms. For example, decreases in dissolved oxygen levels at Church Point to 4.76mg/l on June 30<sup>th</sup>, 3.95mg/l on July 11<sup>th</sup>, 4.36mg/l on September 3<sup>rd</sup>, and 3.31mg/l on September 13<sup>th</sup> coincided with drops in chlorophyll levels (Figure 7). Decreases in dissolved oxygen levels at Otter Point Creek to 1.60mg/l on July 11<sup>th</sup> and 5.50mg/l on October 3<sup>rd</sup> also coincided with drops in chlorophyll levels (Figure 7).

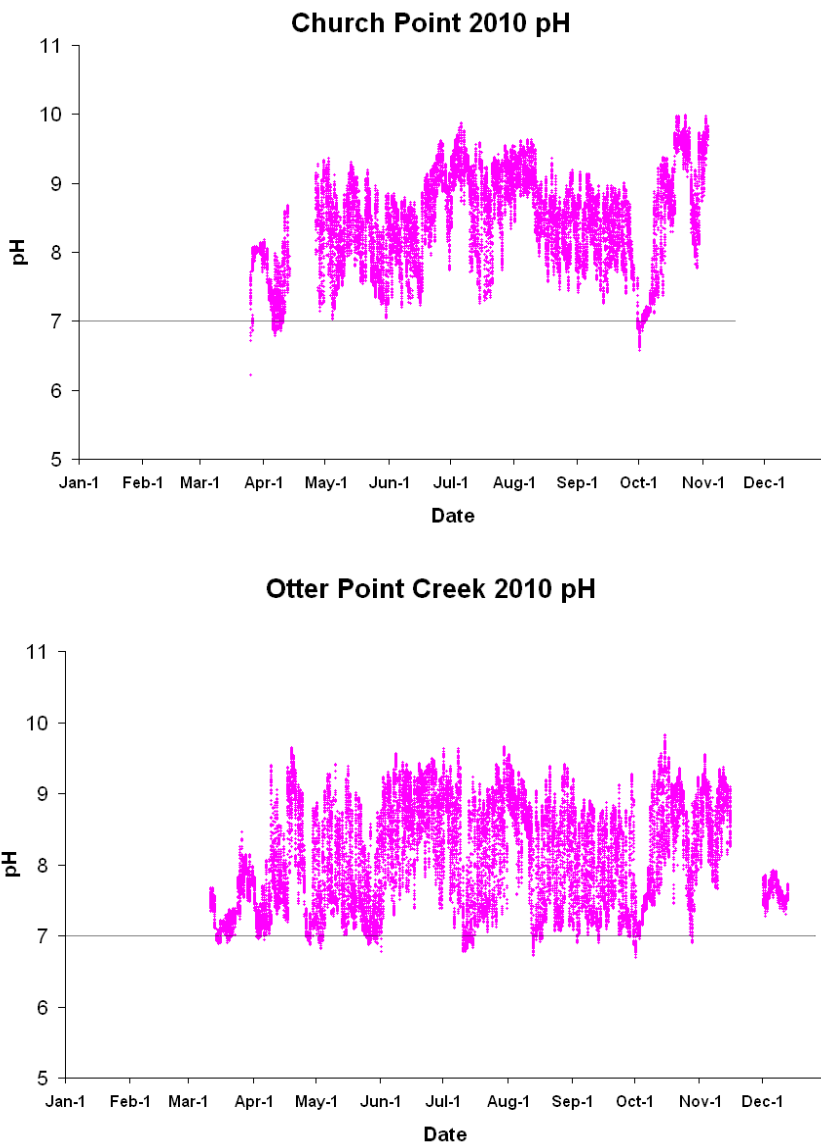
Church Point and Otter Point Creek displayed similar variability in pH levels (Figure 8). Both sites displayed a dip in pH in early April, which followed the second wettest month at BWI Marshall Airport in 2010 (Figure 2), and another dip in mid-July, which coincided with a heavy rain event across Maryland (Table 1). Of note, pH at both sites dropped dramatically in late September following an influx of fresh water into the system from heavy rain and a discharge event associated with the remnants of Tropical Storm Nicole (Table 1; Figure 3). pH at Church Point dropped from 7.7 on September 28<sup>th</sup> to 6.6 on October 1<sup>st</sup>, and then rebounded to 8.9 on October 8<sup>th</sup>. At Otter Point Creek, pH dropped from 7.3 on September 28<sup>th</sup> to 6.7 on October 1<sup>st</sup>, and rebounded to 7.6 on October 8<sup>th</sup>.

**Figure 8. pH levels at Bush River Continuous Monitoring sites during 2010.**

*(Line indicates neutral pH.)*

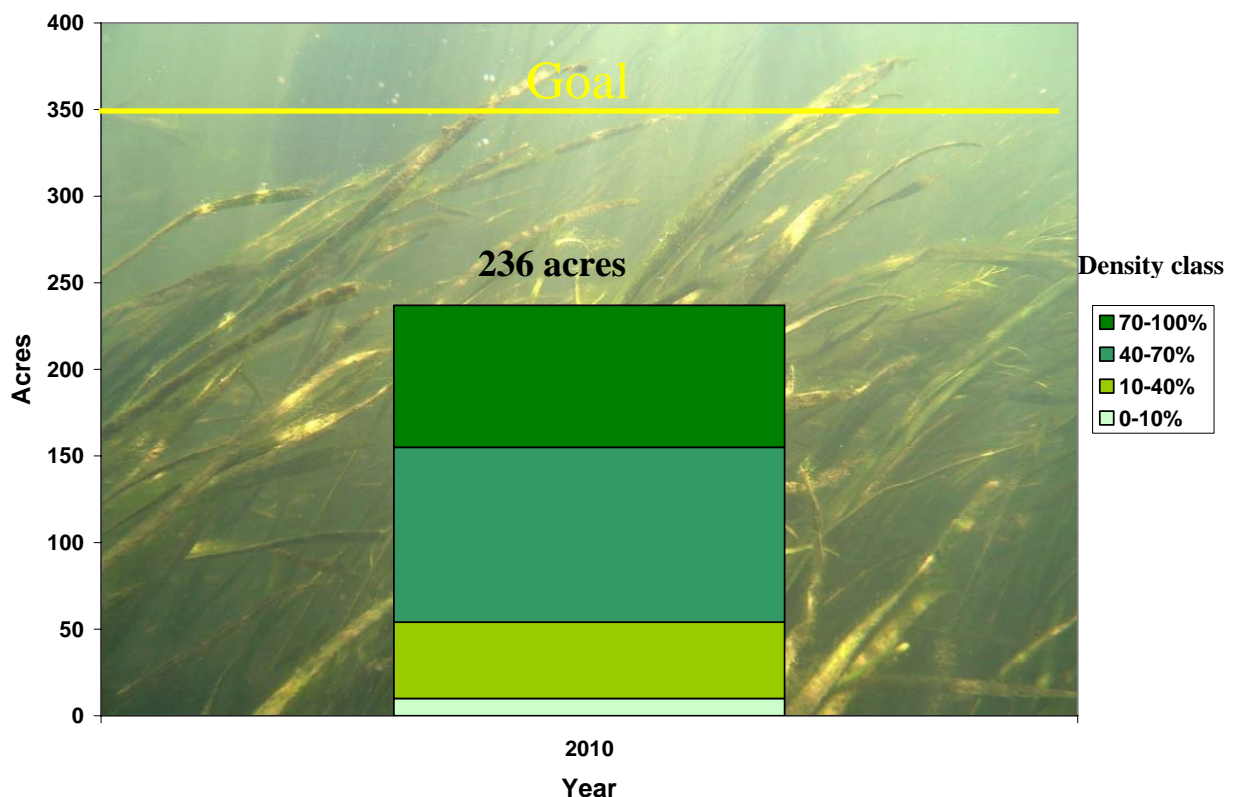
SAV acreage continued a three year decline in the Bush River in 2010 and dropped below the restoration goal for the first time since 2001. Total area of SAV in 2010 was 236 acres, which is 33% lower than the restoration goal for the Bush River (Figure 10). SAV acreage decreased by 38% in the Bush River from 2009 and 63% since the current declining trend began in 2008. Acreage of high density beds has also decreased by 81% since 2007 and measured at 35% of total acreage in 2010. VIMS did not conduct ground survey observations on the Bush River in 2010 so SAV species diversity could not be determined.

Figure 10. Total area and density of SAV in the Bush River in 2010.

The decrease in SAV acreage in the Bush River follows the patterns seen in discharge events and water clarity. There were numerous spikes in daily discharge and runoff events into waterways in 2010 (Figure 3). Water clarity was also poor (Figure 9) and  $K_d$  values (Table 5) indicate that light conditions within the water column were not optimal to facilitate SAV growth.
