**Vertical Profiler Water Quality Monitoring  
in the Tred Avon River –  
June 2016 to December 2016**

March 30, 2017

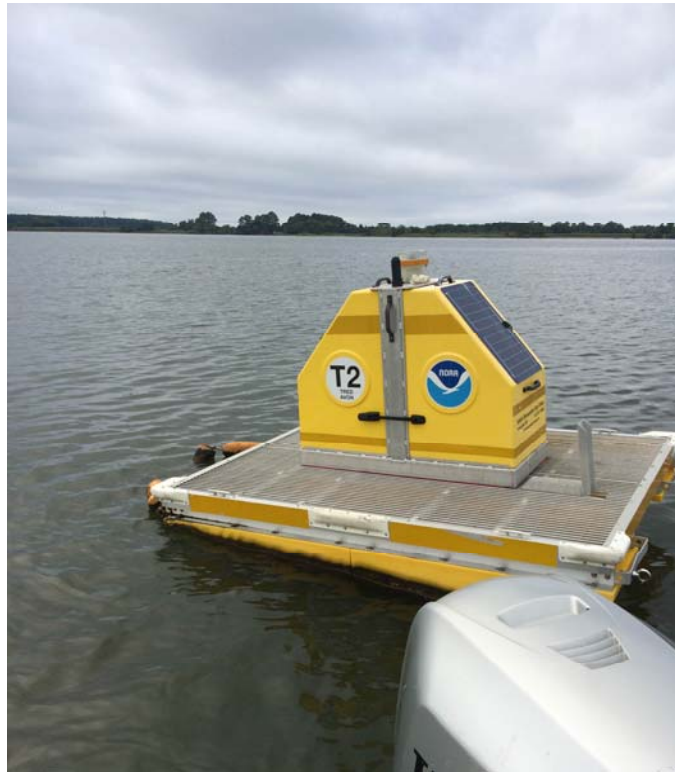
Figure 1. Vertical profiler platform taking on water in one of the platform pontoons (August 16, 2016).

The vertical profiler operated mostly error-free for the 2016 monitoring season. Only two minor mechanical issues interrupted data collection in 2016. The first issue occurred during a routine field visit on August 11 when, during regular maintenance, a plastic coupler on the winch broke. A replacement part had to be ordered, and the profiler sat idle until August 16 when a new coupler was brought out to the site and installed. It was during this repair visit on August 16 that the field crew noticed a second issue: the profiler platform was listing to one side, suggesting

that a leak had formed in one of the platform pontoons (Figure 1). NOAA removed the profiler platform from the Tred Avon River on August 18 to repair the leak. After the leak was repaired, the vertical profiler was redeployed and began collecting data again on August 30, 2016.

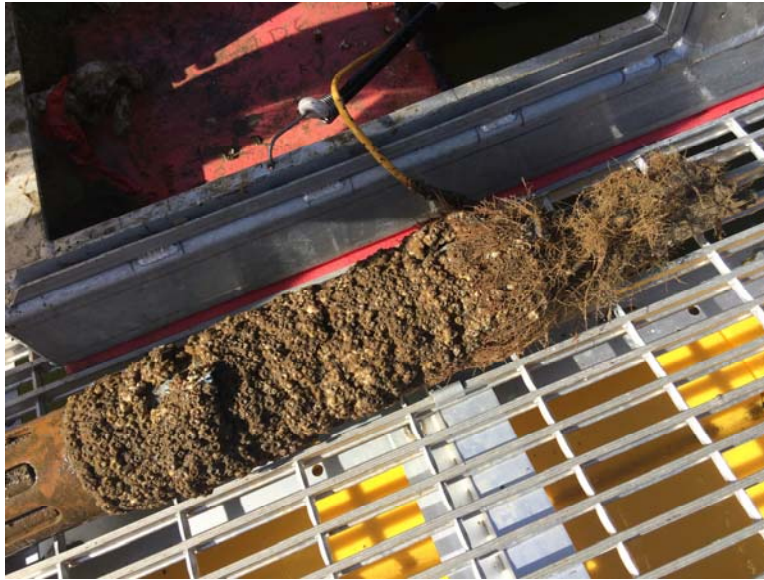
Figure 2. Biofouling on the monitoring sonde at the Tred Avon vertical profiler (August 11, 2016).

As in previous years, biofouling was extensive at the Tred Avon monitoring site. Figure 2 illustrates the biofouling that occurred during a three-week deployment period in August 2016. Biofouling can impair profiler operation and compromise data results.

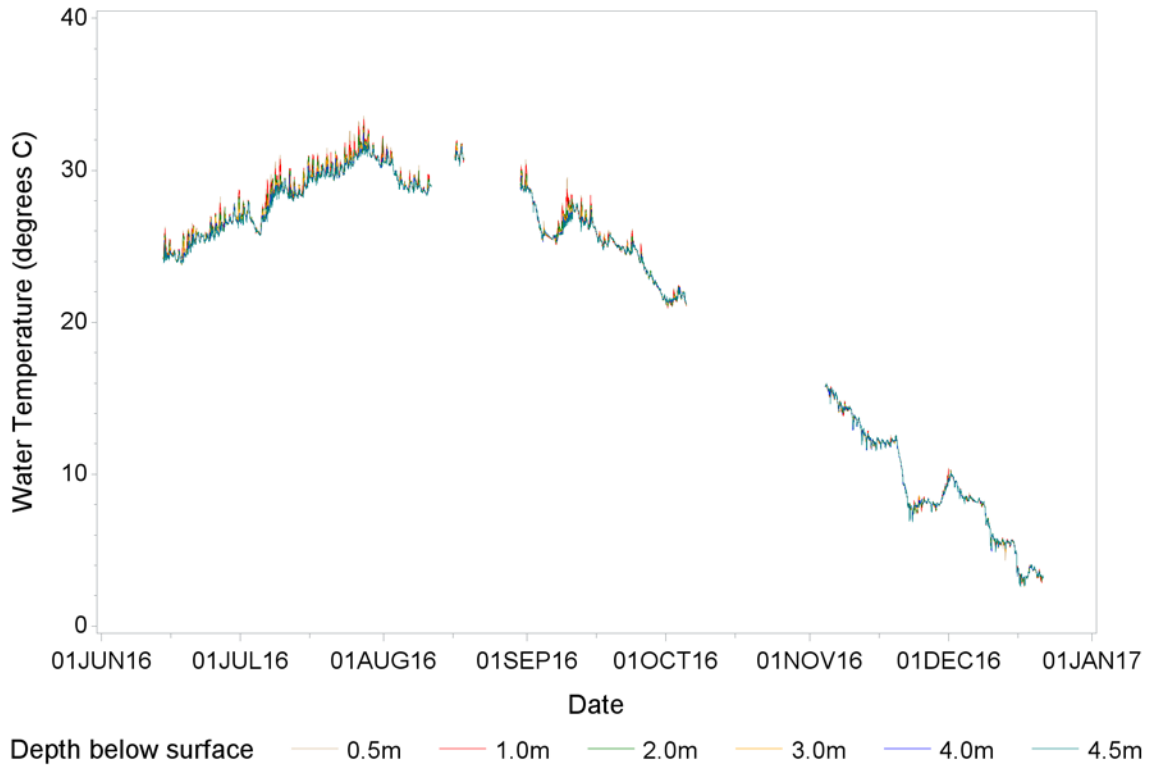
Water temperatures show expected seasonal variability throughout the monitoring season (Figure 3). Temperatures increased from around 25° C in June to peak values around 31° C in late July, and then declined steadily to values around 3° C in December. Chlorophyll values generally remained below 20 µg/l throughout the monitoring period, although a few brief spikes greater than 100 µg/l, indicative of a severe algal bloom, occurred during the month of September (Figure 4). Turbidity readings occasionally spiked during this same September period to values greater than 30 NTU (Figure 5). Otherwise, turbidity was typically less than 15 NTU, with frequent, smaller spikes between 15-30 NTU. Salinity values were between 12-13 ppt for most of the summer season, but began to increase in September and rose to values above 16 ppt in November and December (Figure 6). Values for pH in the Tred Avon River ranged between 7.4 and 8.5, with slightly higher values observed in late December (Figure 7). The values for salinity and pH were both within the ranges considered to be favorable for oyster habitat (<https://chesapeakebay.noaa.gov/fish-facts/oysters>). Dissolved oxygen, which generally ranged between 5-10 mg/l for June through October, increased to more than 10 mg/l in late November through December (Figure 8). During several weeks in September, dissolved oxygen in the bottom waters (4.5m depth) dropped below 5 mg/l.

Data collected during profile sequences are shown in Figures 3-8. These plots show data values over time with the data at each depth represented by a different line. The plots show the entire data record from June through December 2016. Breaks in the line are due to gaps in the data record, either as a result of missing data collection or censoring the data through the QA process.

Water quality conditions at the site show slight differences between surface and bottom values. Generally, temperature, chlorophyll, and pH values were slightly greater at the surface, and turbidity and salinity were slightly greater near the bottom. Dissolved oxygen values at the surface were about 1 mg/l greater than bottom water values, but when bottom dissolved oxygen dropped below 5 mg/l in September, the surface and bottom values differed by nearly 3 mg/l.

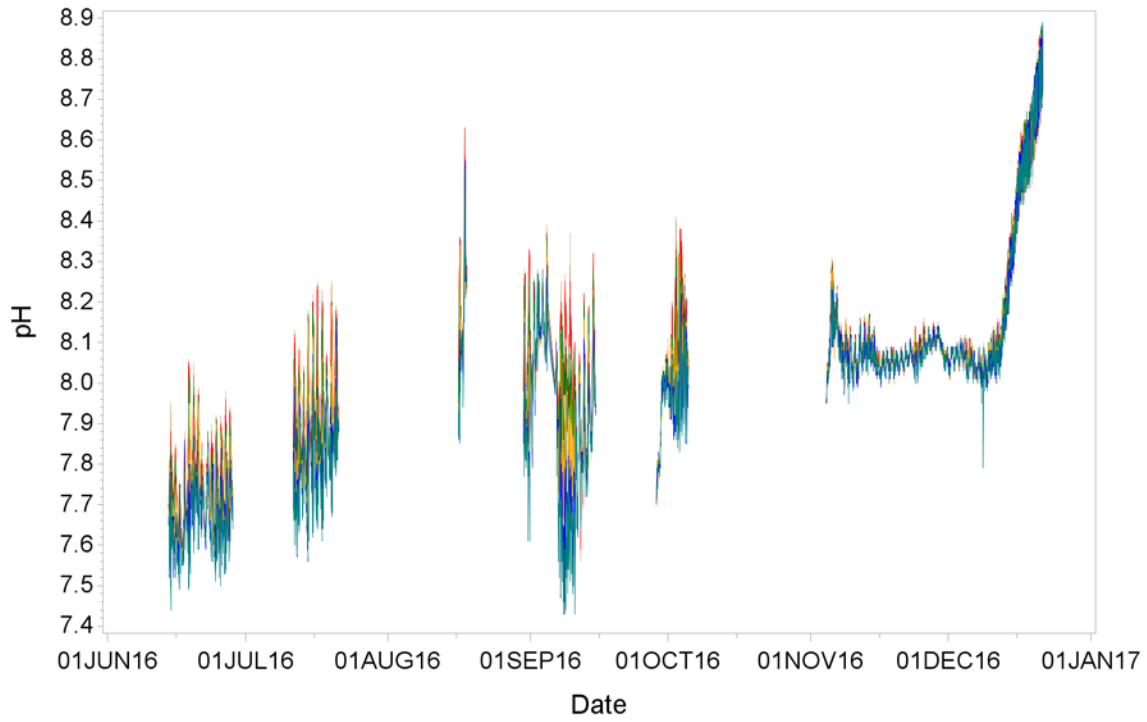
Depth below surface — 0.5m — 1.0m — 2.0m — 3.0m — 4.0m — 4.5m  
 Figure 7. pH in the Tred Avon River during 2016.

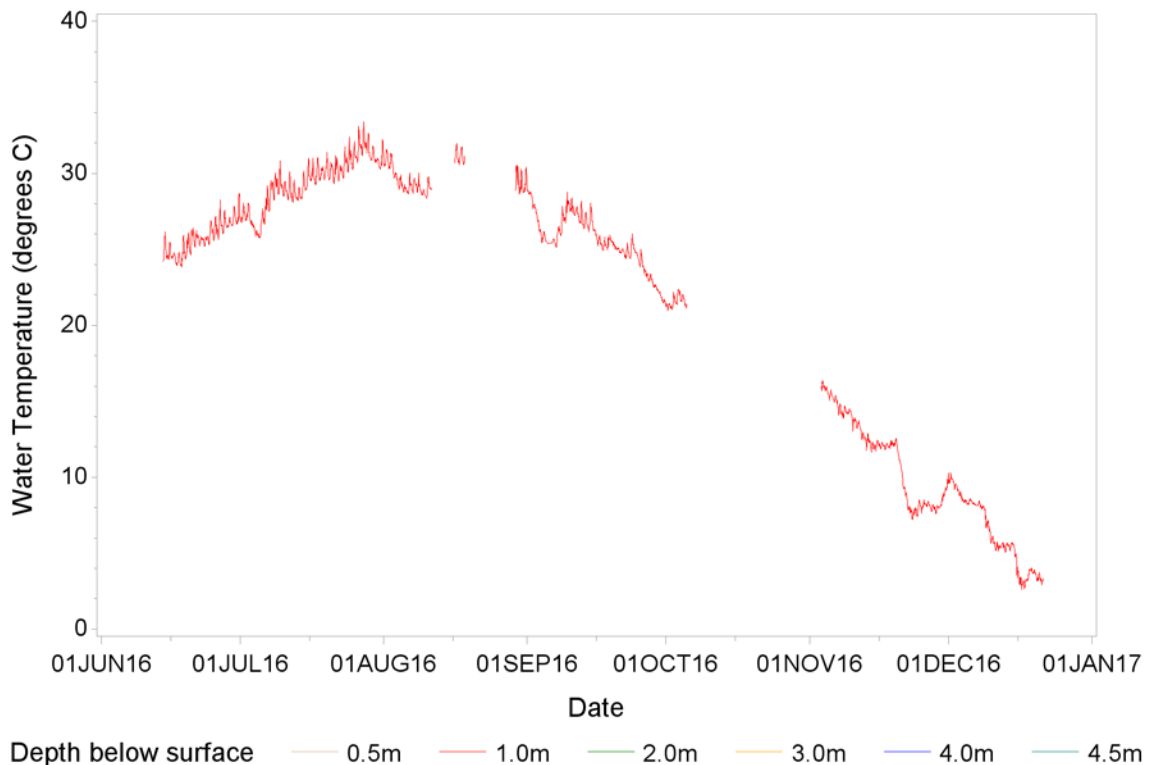
Figure 9. Hourly readings for water temperature in the Tred Avon River during 2016.

The results of the hourly readings are presented in Figures 9-14 and are consistent with the profile results presented above. Hourly readings were collected once per hour at a time when the sonde was resting in the 1 meter parked position. When errors cause the vertical profiler to stop collecting profile readings, the instrument usually continues to collect hourly readings. Thus, the data record for the hourly readings can be slightly more complete than the record for profile readings. As mentioned previously, the Tred Avon vertical profiler experienced relatively few instrument malfunctions in 2016, and so the data record of hourly readings closely matches that of profile readings.

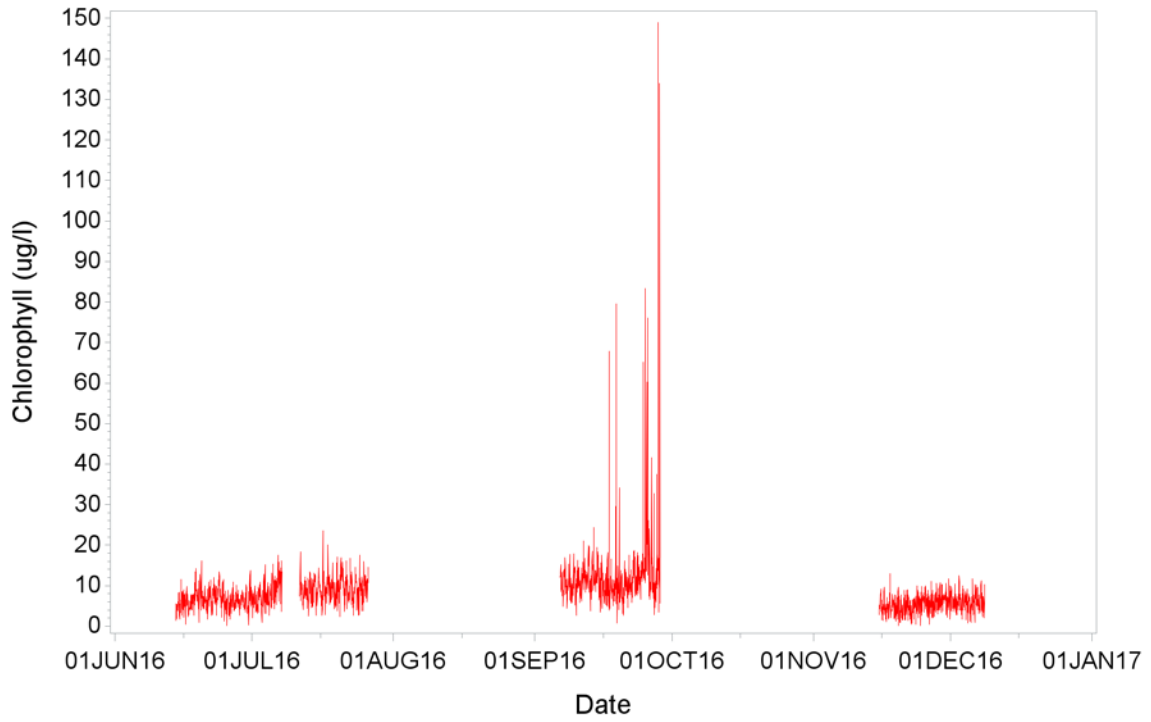
Figure 10. Hourly readings for chlorophyll in the Tred Avon River during 2016.

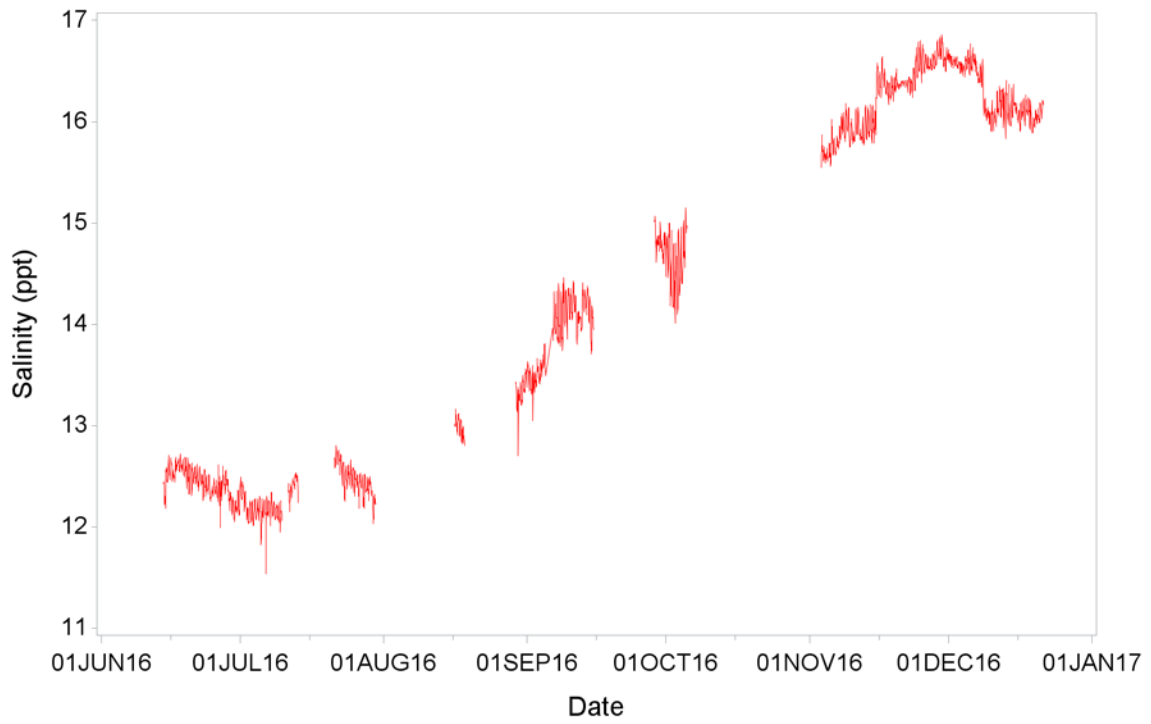
Figure 12. Hourly readings for salinity in the Tred Avon River during 2016.

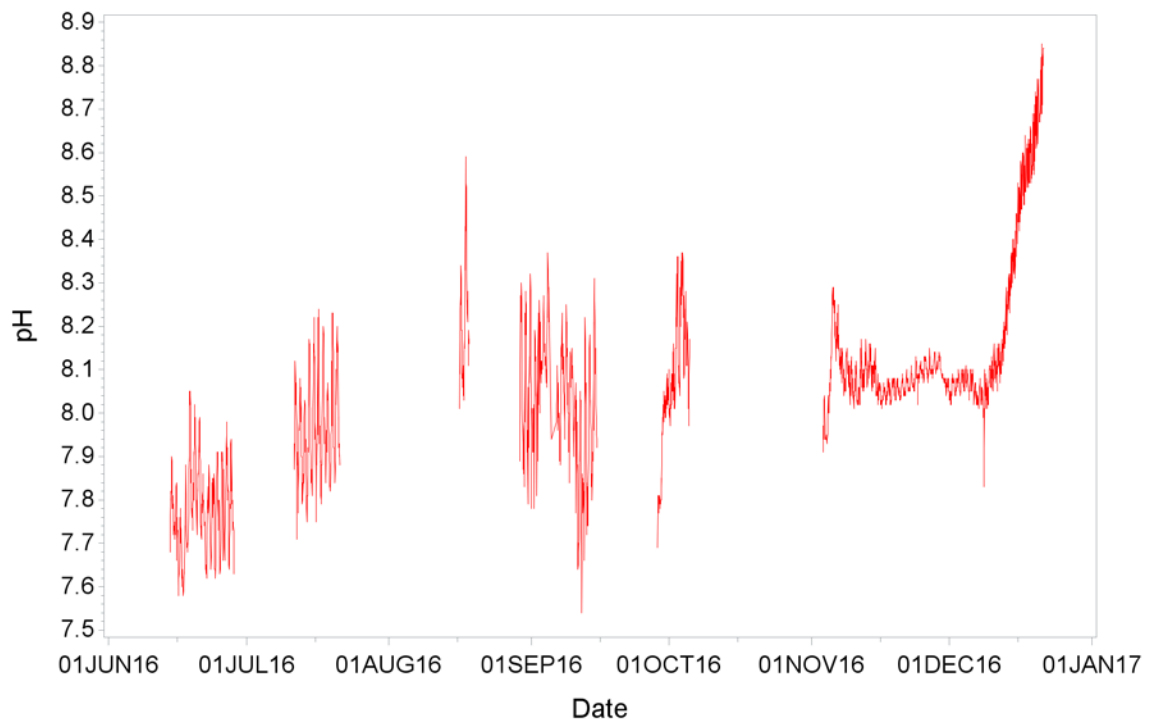
Figure 13. Hourly readings for pH in the Tred Avon River during 2016.

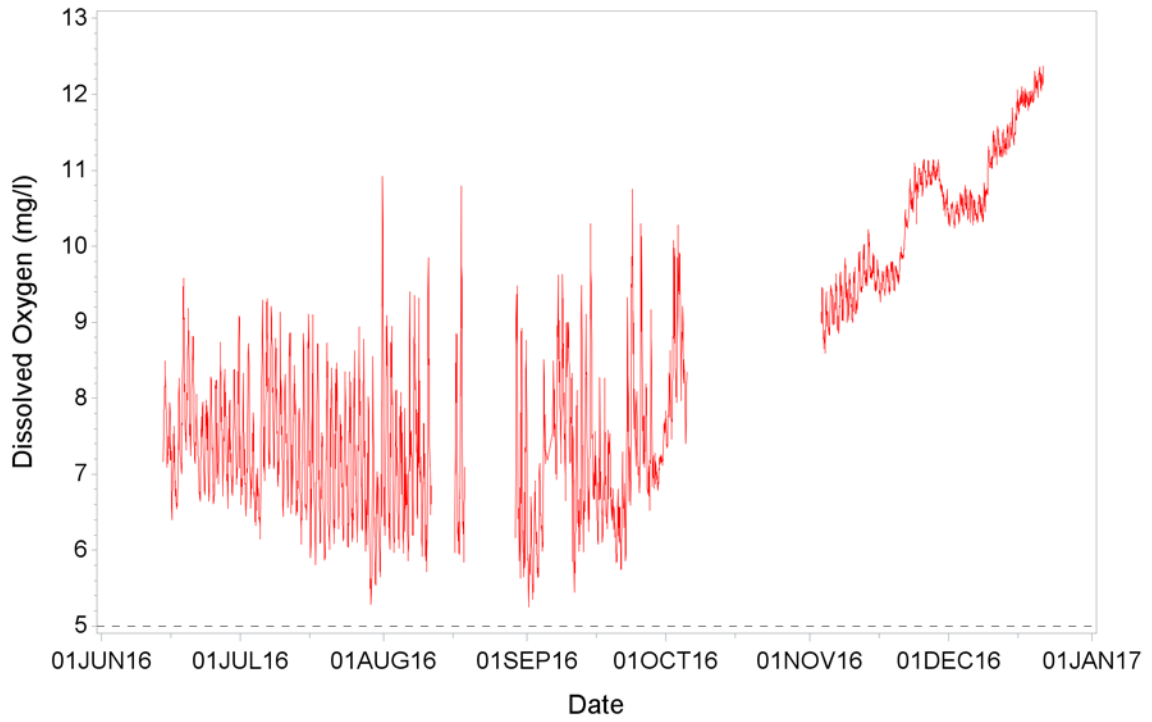
Figure 14. Hourly readings for dissolved oxygen in the Tred Avon River during 2016.
