**Vertical Profiler Water Quality Monitoring  
in the Tred Avon River –  
June 2017 to December 2017**

March 7, 2018

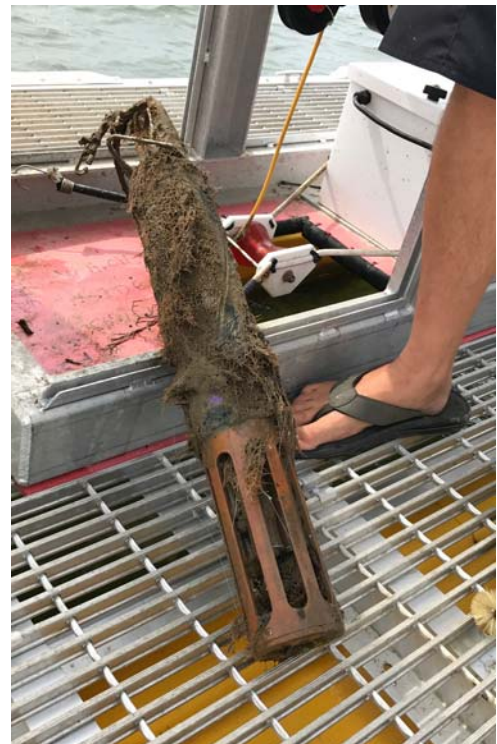
**Figure 1. Biofouling on data sonde after an extended deployment at the Tred Avon profiler (July 27, 2017).**

By late July 2017, the sonde that was deployed at the Tred Avon profiler was so heavily fouled (Figure 1) that on-site cleaning was no longer a viable option. Since a clean, calibrated sonde was still unavailable, DNR staff instead replaced the Tred Avon sonde with one that had just been removed from the DNR monitoring site in Harris Creek. Thus, the sonde installed on the Tred Avon profiler on July 27 was not properly cleaned and calibrated in the laboratory prior to deployment. On the next scheduled field visit (August 17), the same procedure was followed – replacing the sonde at the Tred Avon site with a sonde that had just been removed from the Harris Creek site. Replacing the sondes in this manner allowed data collection to continue uninterrupted at the Tred Avon site. If instead, field staff had removed the Tred Avon sonde and not installed any replacement sonde, at least two weeks of data collection would have been missed as the single sonde was in the laboratory being cleaned, calibrated, and readied for redeployment. However, recognizing that the sondes installed at the Tred Avon site in August were not calibrated prior to deployment, the data collected during this time period should be closely scrutinized.

As in previous years, biofouling continued to be an issue at the Tred Avon monitoring site in 2017. In fact, the extended deployment of the initial sonde resulted in such heavy fouling that when the instrument was finally returned to the field office at the end of July, it could not be post-calibrated. Figure 1 and Figure 2(a-b) show the growth that was present when the sonde was retrieved on July 27, 2017. Severe biofouling such as this can impair profiler operation and compromise data results. Since equipment at the Tred Avon monitoring site is prone to such extensive fouling, routine maintenance is especially important to ensure data quality.

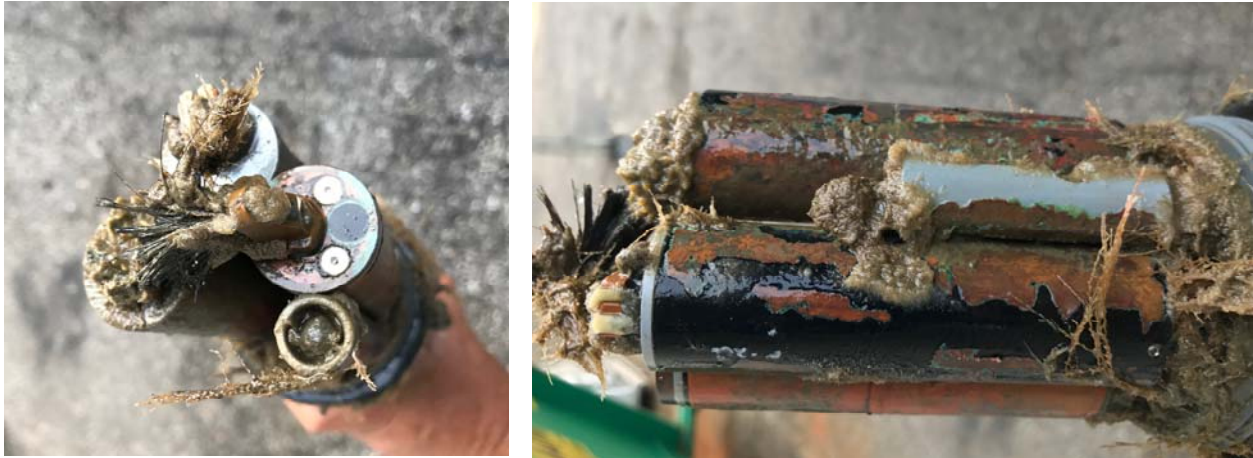
**Figure 2(a-b). Biofouling on data sonde after an extended deployment at the Tred Avon profiler (July 27, 2017).**

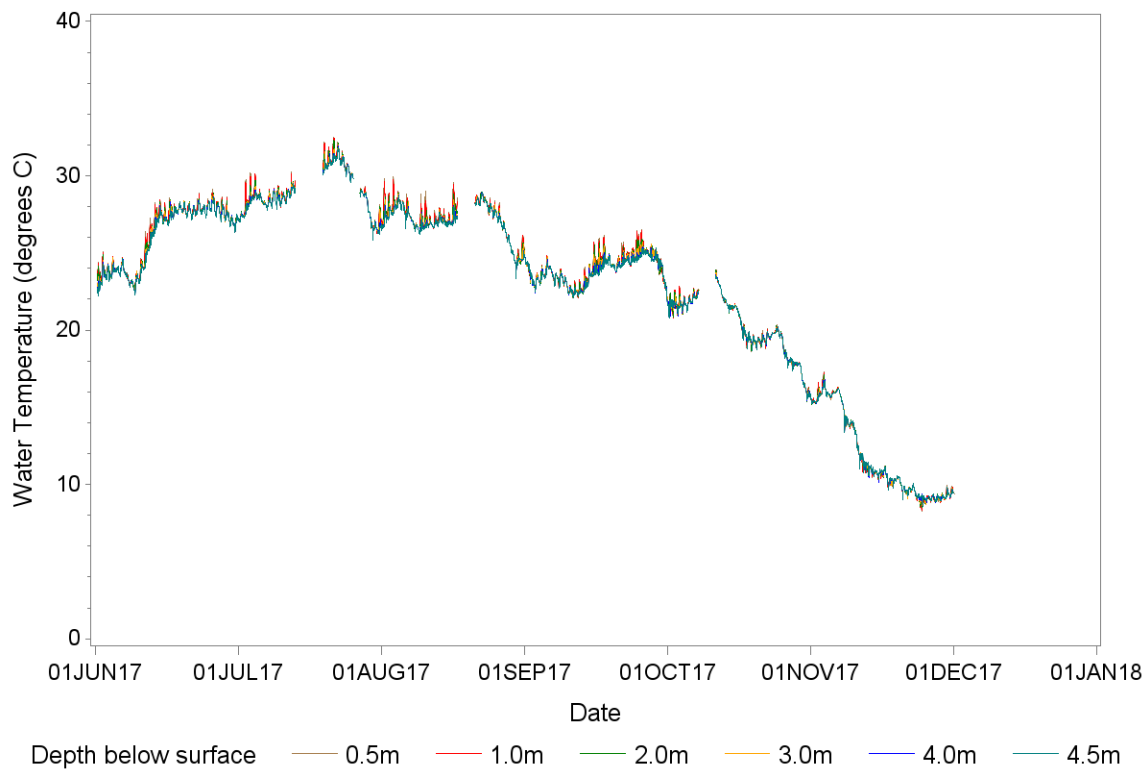
Figure 3. Water temperature in the Tred Avon River during 2017.

Water temperatures show expected seasonal variability throughout the monitoring season (Figure 3). Temperatures increased from around 24° C in June to peak values around 32° C in late July, and then declined steadily to values around 9° C in late November. Surface temperatures were only slightly warmer than the bottom water temperatures, with less than a 1° C difference between the two.

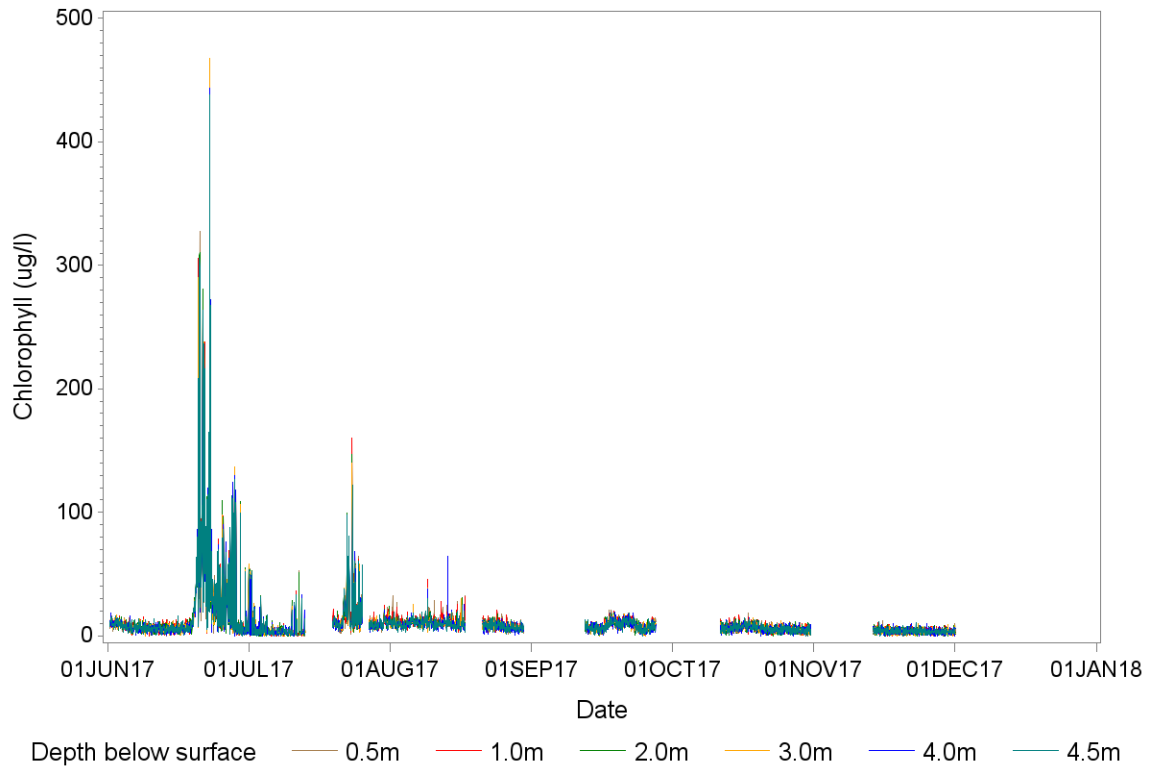
Figure 4. Chlorophyll in the Tred Avon River during 2017.

Chlorophyll and turbidity values for 2017 show especially high values during the months of June through August. Chlorophyll values greater than 100 µg/l were recorded in late June and in late July (Figure 4). Turbidity values greater than 50 NTU were often recorded during June, July and August 2017 (Figure 5). However, these high values for chlorophyll and turbidity may not represent conditions in the water column, but may instead reflect the heavy fouling of the equipment that occurred through the summer months. While biofouling is always an issue at the Tred Avon site, in 2017 the problem was exacerbated by the lack of a replacement sonde for the vertical profiler. As previously noted, the sonde that was initially deployed at the profiler on June 1 remained in the field until July 27 with only occasional on-site cleaning. Then, throughout August, the sondes that were deployed at the Tred Avon site were DNR instruments that were moved to the Tred Avon site without first being cleaned and calibrated. It is important to consider these operating conditions when interpreting the high readings for chlorophyll and turbidity during June-August. During September through December, less biofouling typically occurs, and the sondes were regularly cleaned and calibrated. Chlorophyll and turbidity values during this time remained consistently low. Generally, chlorophyll values were less than 20 µg/l and turbidity values were less than 10 NTU during September-December 2017.

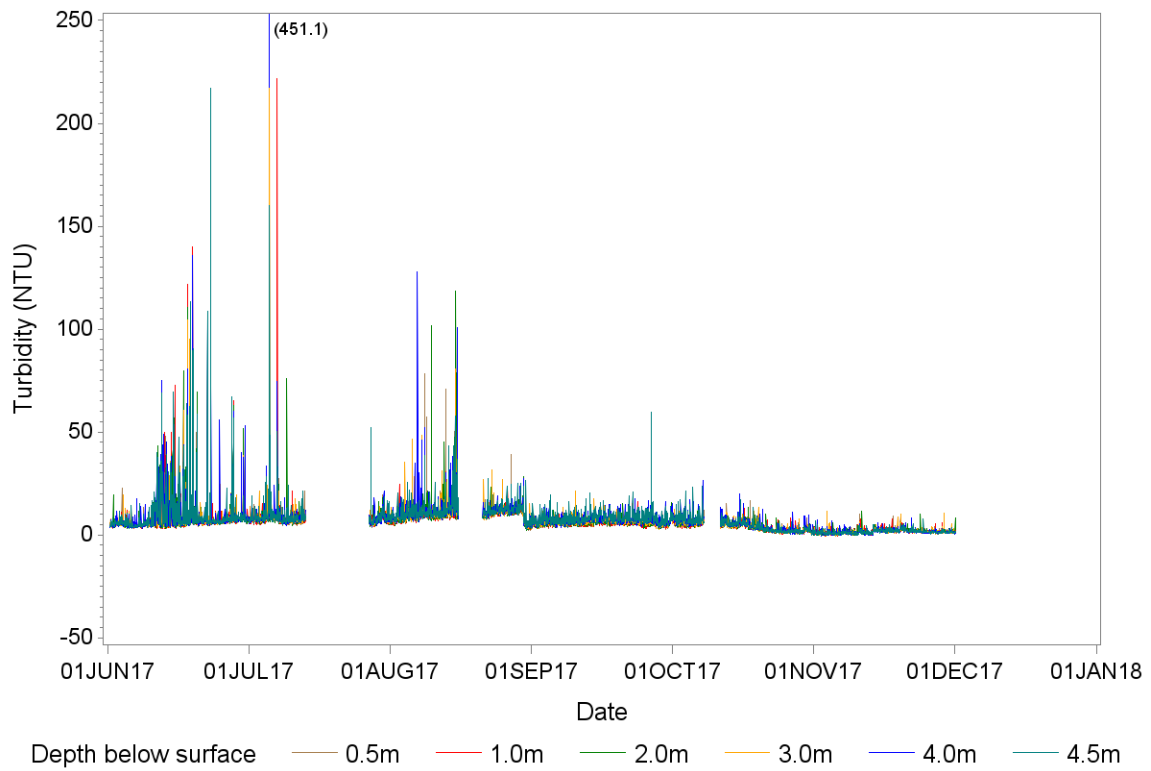
Figure 5. Turbidity in the Tred Avon River during 2017.

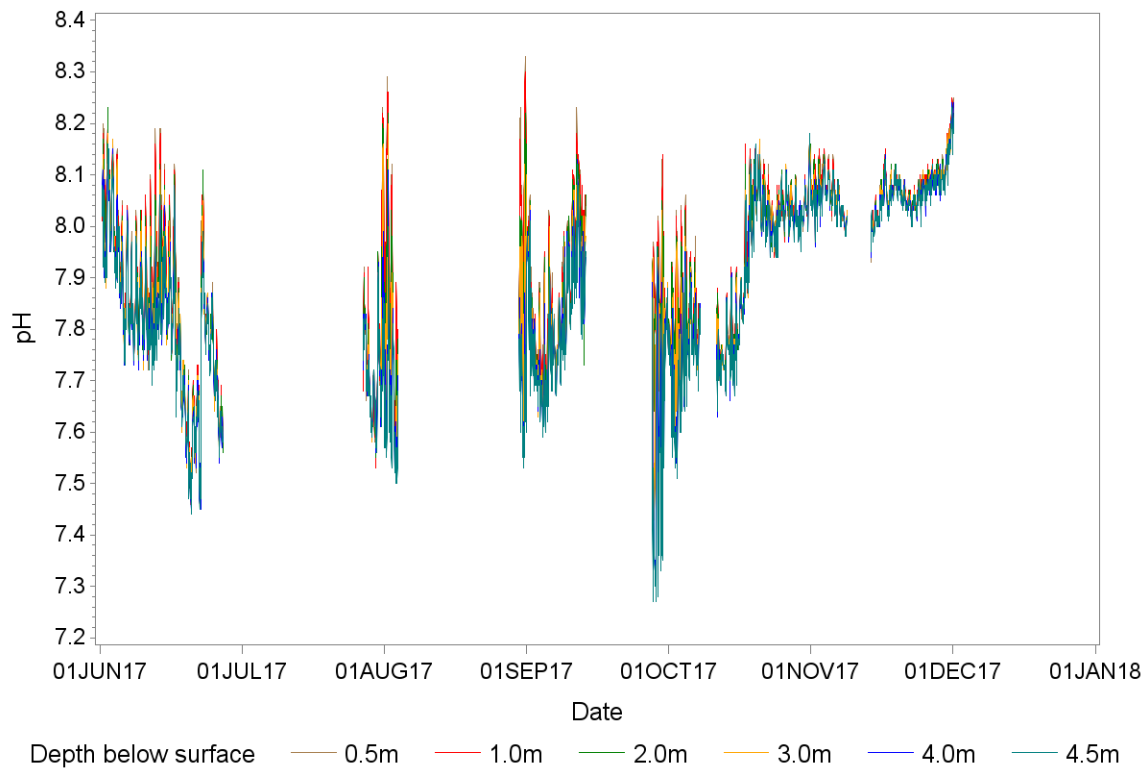
Figure 7. pH in the Tred Avon River during 2017.

since they do not include a wiper to clear biological growth from the probe. Over the course of each sonde deployment period, salinity values at the Tred Avon site slowly declined as biofouling increased on the instrument. Due to this drift in data values, significant portions of the salinity data record were determined to be unreliable and were censored during data quality review. Generally, however, 2017 salinity values were between 9.5 ppt and 11 ppt for June through mid-September, rose quickly from late September through early October, and then remained between 14.5 ppt and 15.5 ppt for the rest of the year (Figure 6). Surface salinity values were slightly ( $<0.5$  ppt) less than the bottom values. Values of pH ranged between 7.3 and 8.3 through the 2017 monitoring season, with surface water pH values slightly higher than bottom pH values (Figure 7).

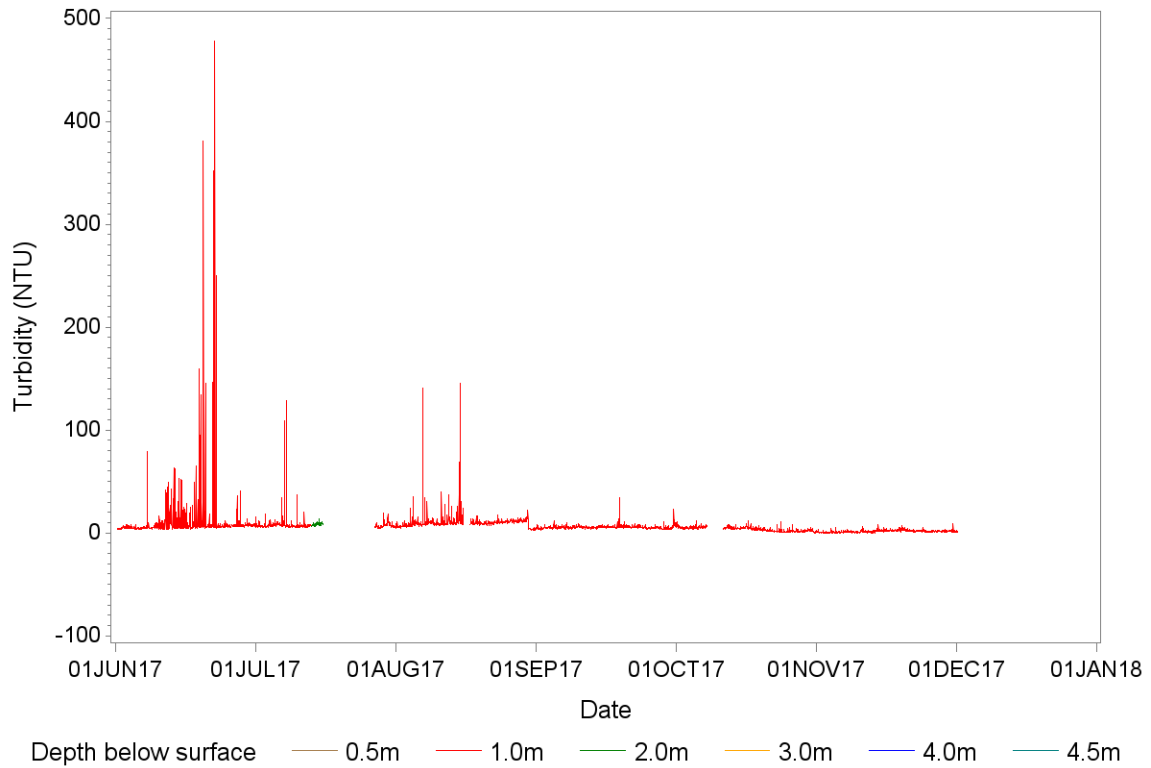
Figure 11. Hourly readings for turbidity in the Tred Avon River during 2017.

The results of the hourly readings are presented in Figure 9 through Figure 14 and are consistent with the profile results presented above. Hourly readings were collected once per hour at a time when the sonde was resting at the 1 m depth in a parked position. When errors cause the vertical profiler to stop collecting profile readings, the instrument usually continues to collect hourly readings. Thus, the data record for the hourly readings can be slightly more complete than the record for profile readings.

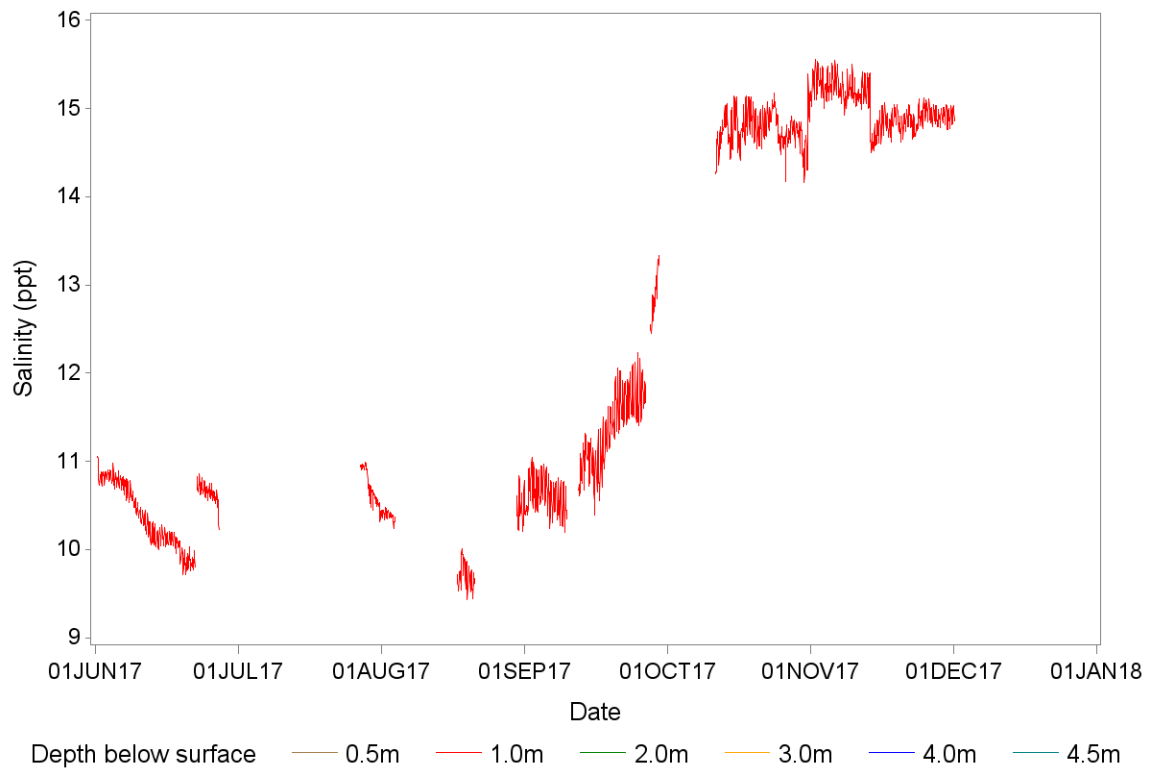
Figure 12. Hourly readings for salinity in the Tred Avon River during 2017.

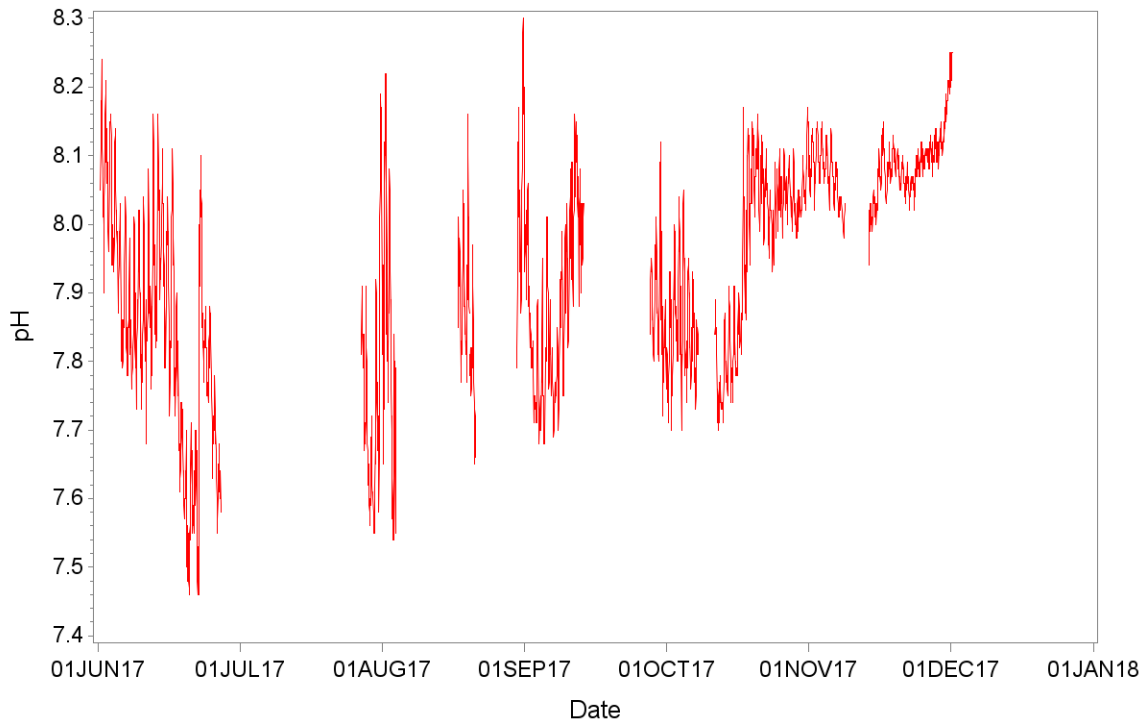
Figure 13. Hourly readings for pH in the Tred Avon River during 2017.

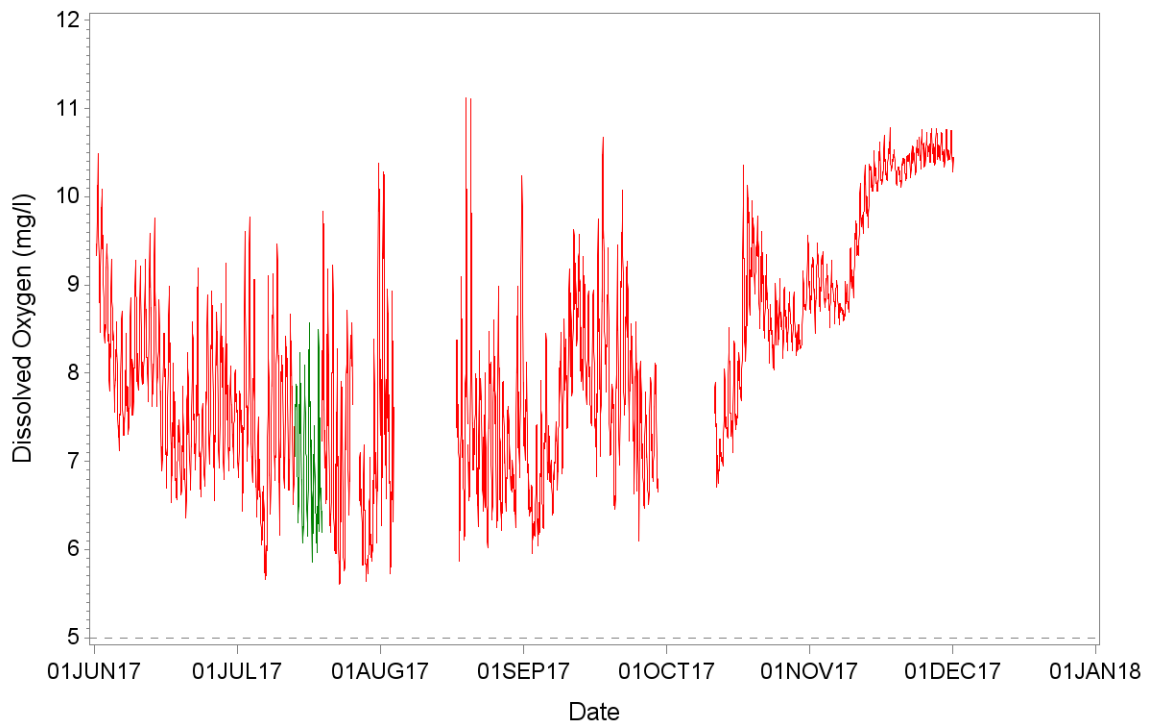
Figure 14. Hourly readings for dissolved oxygen in the Tred Avon River during 2017.
